CASE STUDY

EQUIPMENT: Cooling Tower Concrete Basin

PROBLEM: The concrete basin developed various cracks which caused water loss to the ground.

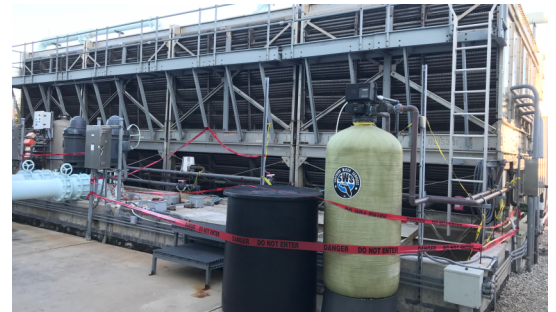
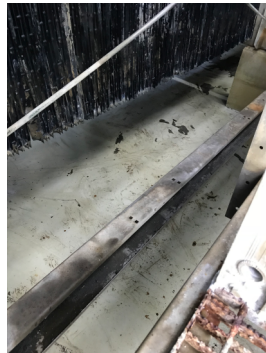
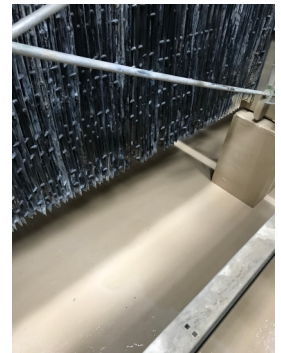
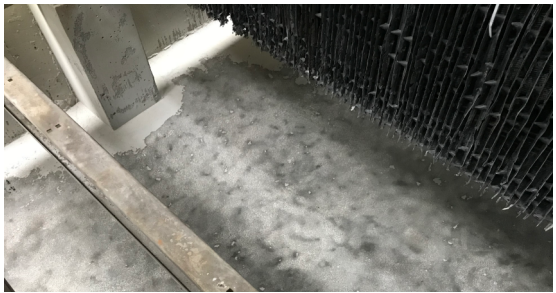
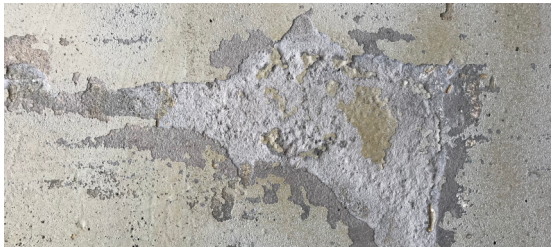
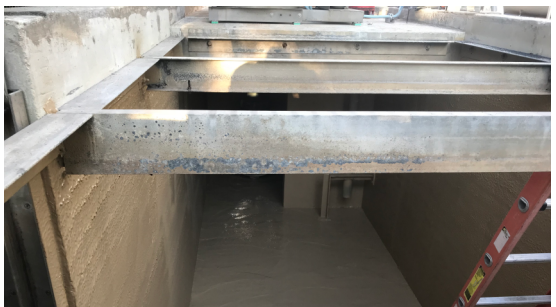
The cooling tower system's water consumption increased year after year with no explanation. After thorough inspection, it was evident the concrete basin had developed various cracks from years of operation. The basin had been originally coated with an epoxy material. The stiffness of the epoxy did not withstand the soil movement and cracked along with the concrete basin. The facility owner needed a long term, cost effective leak repair with minimal downtime.

Repairing the cracks with concrete patches would not guarantee the basin would stop leaking as it is a porous material. The new concrete would have poor adhesion to the existing concrete and deem unreliable. A new coating was needed to seal the concrete. The epoxy option was avoided as it would create the same failures. Our solution utilized Rhino Liner 11-50 due to its high resistance to chemicals as well as its flexibility characteristics. If the problem persists, and cracks develop, our liner would still provide protection to the basin and prevent leaks. The Rhino Liner 11-50 cures in minutes once applied, which minimizes downtime.

The project was completed in only 5 days. Our solution created a permanent durable cooling tower basin.
