CASE STUDY

EQUIPMENT: Cooling Tower

PROBLEM: Basin leaks

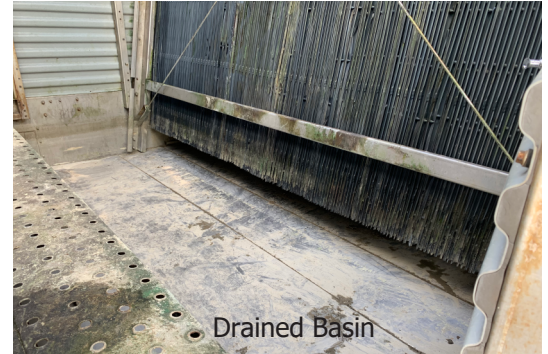
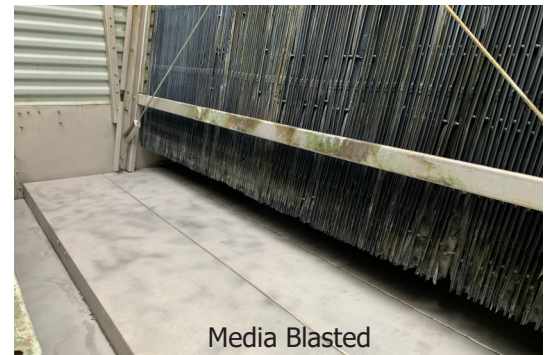
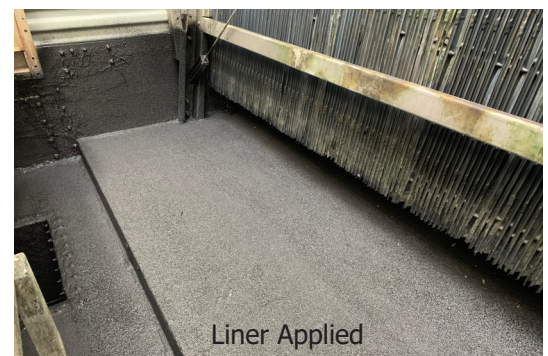
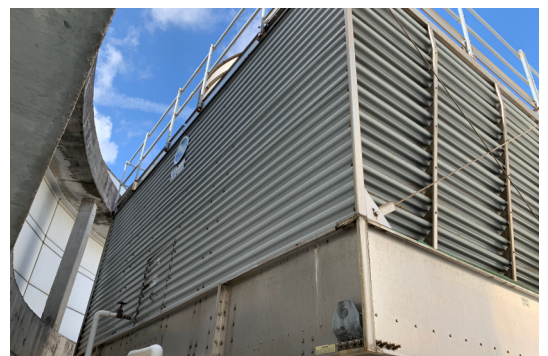
The basin of the cooling tower developed various leaks from failures at the joints. This is a common issue in units that have been in operation for 10+ years. The facility owner did not have the budget to replace the cooling tower and was looking for an alternative solution.

We offered a specialized liner application that is reliable, and permanent. Our application process involves media blasting the stainless steel basin to remove the oxidation, rust, and old caulking. The liner is then sprayed in place to form a new basin. Rhino 11-50 liner was selected for this application. The liner has a high resistance to chemicals, and can shift with the contraction and expansion of the pan. Our application cures within minutes minimizing downtime.

The project was completed within two days over the weekend when the building required a lesser cooling load. The downtime did not affect the facility. Our solution created a durable, flexible cooling tower pan that provides a permanent solution for the facility. To date, there have been no report of leaks or degradation in the areas protected by our application.
