## **CASE STUDY**

**EQUIPMENT:** Cooling Tower Structural I-Beams **PROBLEM:** Corroded I-Beams at risk of structural failure.

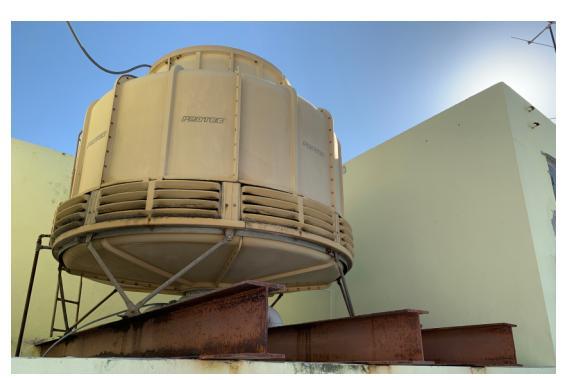
Extensive corrosion was visible on the cooling tower support I-Beams. Corrosion on the I-Beams can risk structural integrity of the tower. Replacement of the beams would require the involvement of a structural engineer, and would not solve the corrosion issue. The owner was unaware of any other solution.

Original I-beam condition

The structural integrity of the beams had not yet been compromised. We were able to provide a low cost solution by reconditioning the existing beams. Our proprietary multilayered coating application Surfsil CX was utilized due to is high resistance to: impact strength, chemicals, and corrosion. The steel surfaces were media blasted to SSPC/NACE standards to remove the existing corrosion and create the proper profile for our coating application. Prior to coating, a metal compound paste was applied to resurface the beams as well as remove any pit holes that would cause water and chemicals from the cooling tower to accumulate.

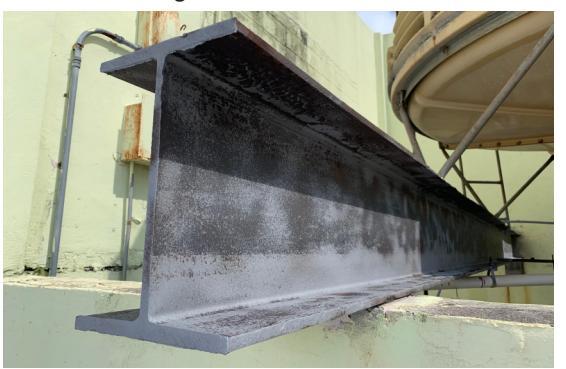
Media blasting procedure

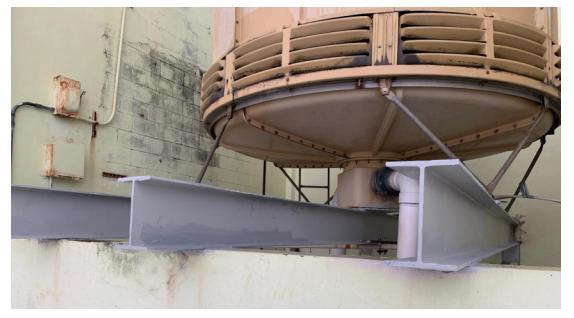
Application of Surfsil CX multi-layer coating process

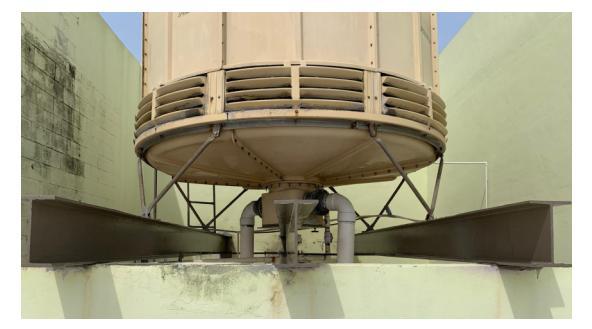
UV resistant coating applied

The project was completed in only 5 days while the unit was fully operational. Our solution will provide permanent protection against corrosion, chemicals, and UV attacks.
